# **2015 ANNUAL ENGINEERING INSPECTION REPORT**

## **ENERGY INDEPENDENCE PLANT CLASS 3N LANDFILL**

**PERMIT NO. 0200-S3N-R2  
AFIN: 32-00042**

**JANUARY 15, 2016**

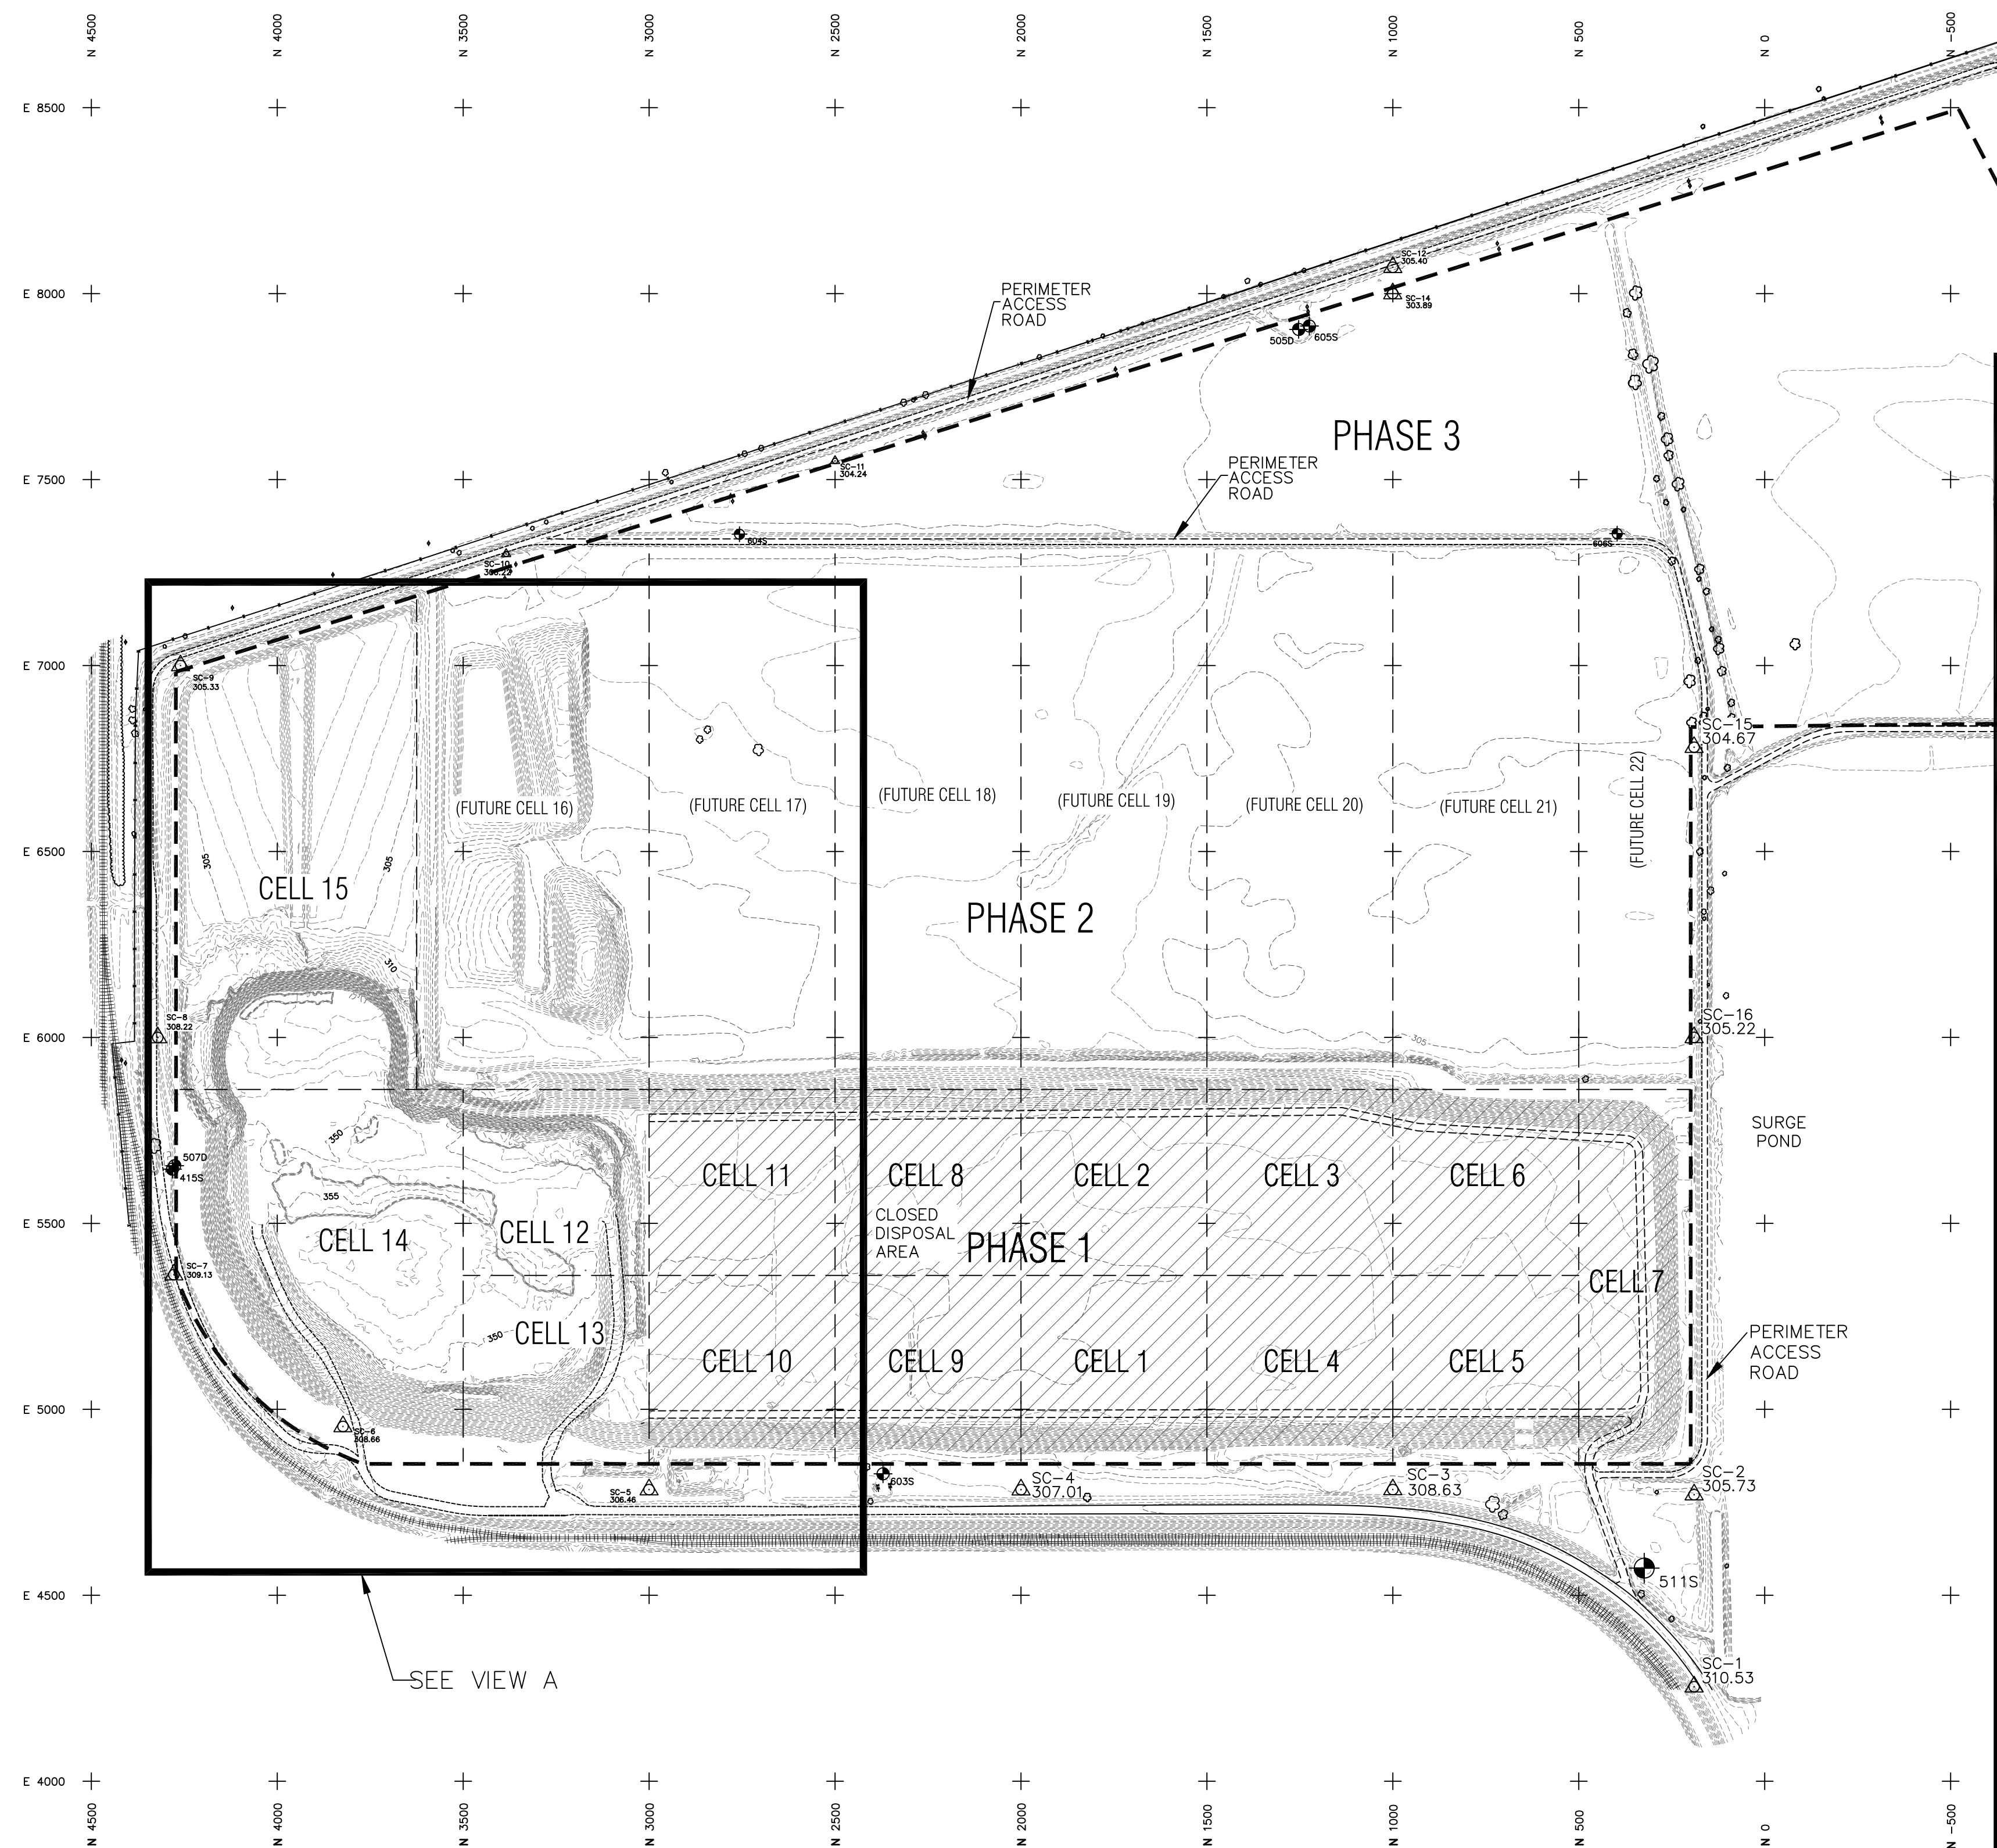
**FIGURE 2  
EXISTING CONDITIONS**

Based upon the digital terrain model, the net volume of material filled in Waste Cells 12 through 15 during the reporting period was calculated to be approximately 48,700 cubic yards (cy). Final permitted contours are shown in Figure 3. Based upon a 5-year historical annual average disposal rate of approximately 124,800 cy of material, there are about 8.9 years of capacity left in Waste Cells 12 through 15. This time frame is affected by the market for ash material and may be shorter or longer depending on market conditions.

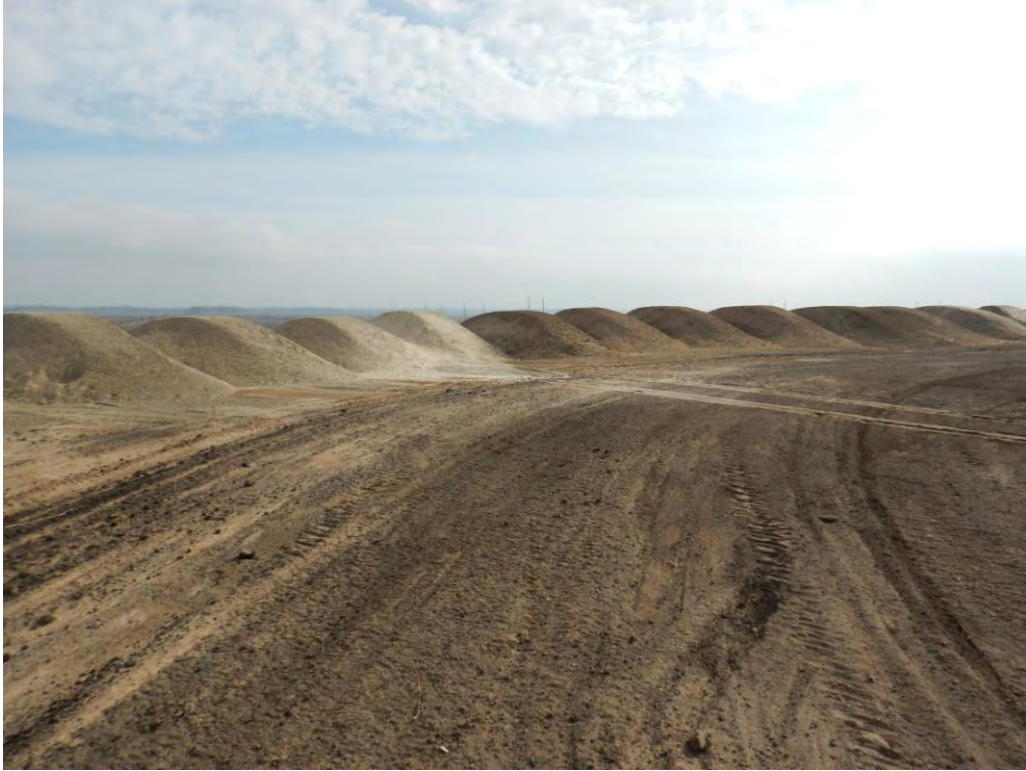
Photo 1. Active working face in Cell 15 looking southeast.

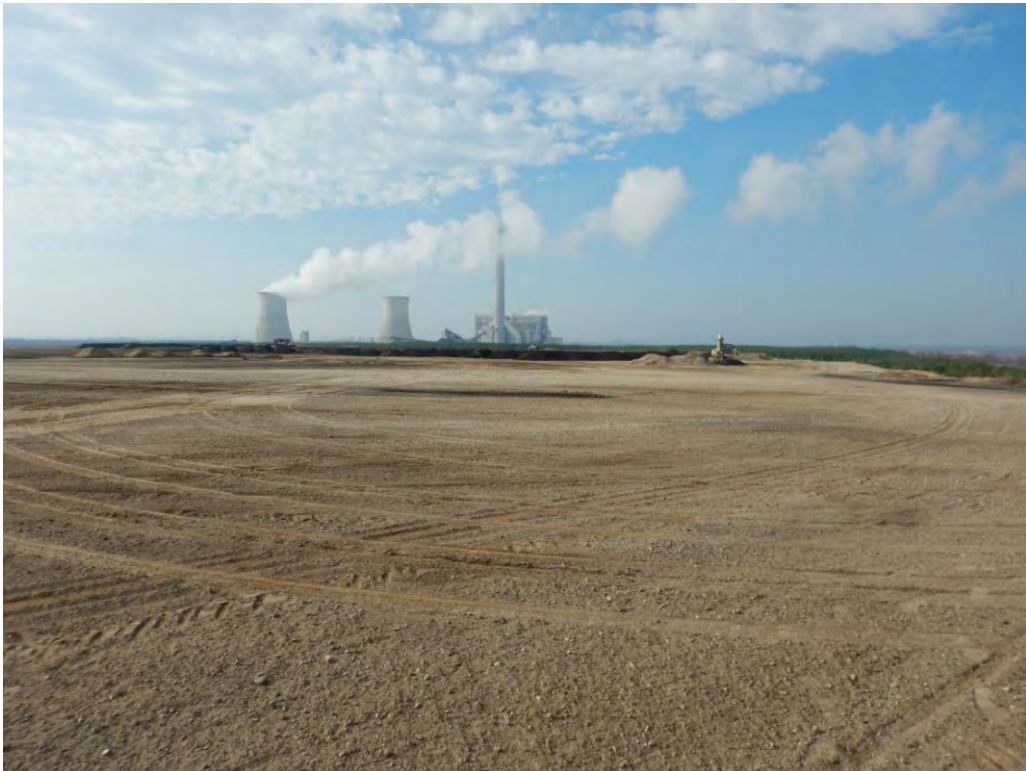
Photo 2. Cells 12, 13, 14 and 15 looking southwest.

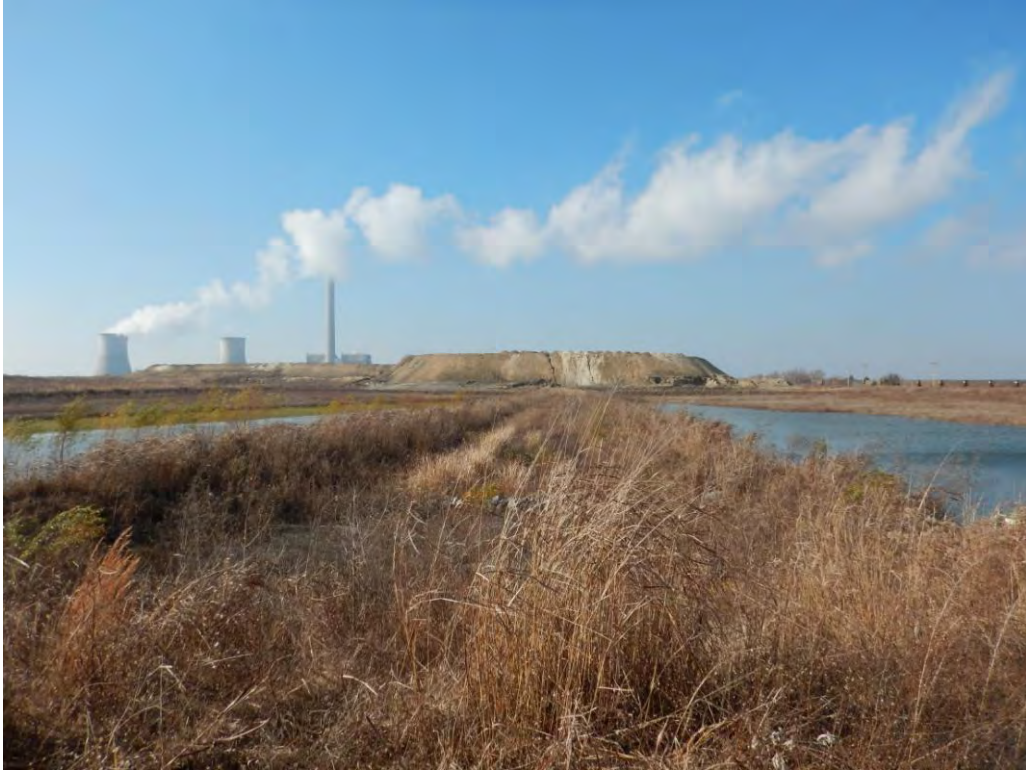
Photo 3. Leachate sump in Cell 15 looking west.

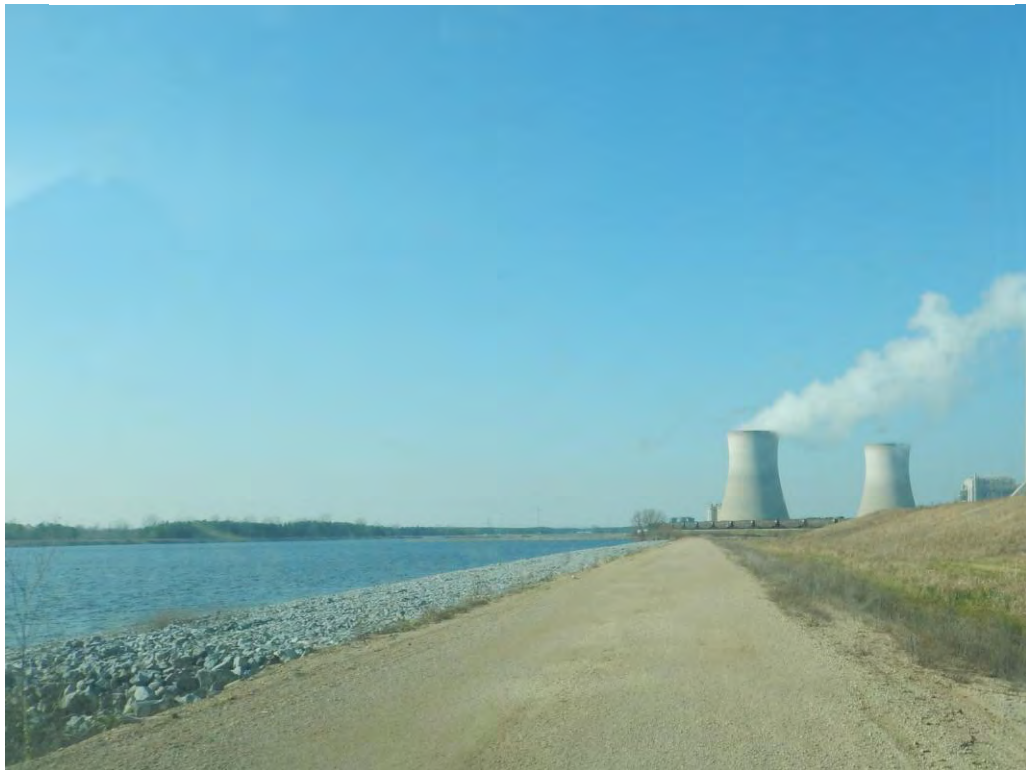
The facility roads were well maintained at the time of the inspection. The disposal access road to the active cells is paved, and it was in excellent condition at the time of the inspection. The perimeter access road has an all-weather surface coarse and was in good condition.

Photo 4. Landfill perimeter access road looking west.
