# 2019 Recycle Pond A Inspection Report

Entergy Arkansas, LLC White Bluff Plant  
Recycle Pond A (South)  
Redfield, Arkansas

January 2020  
Project No. 35197248

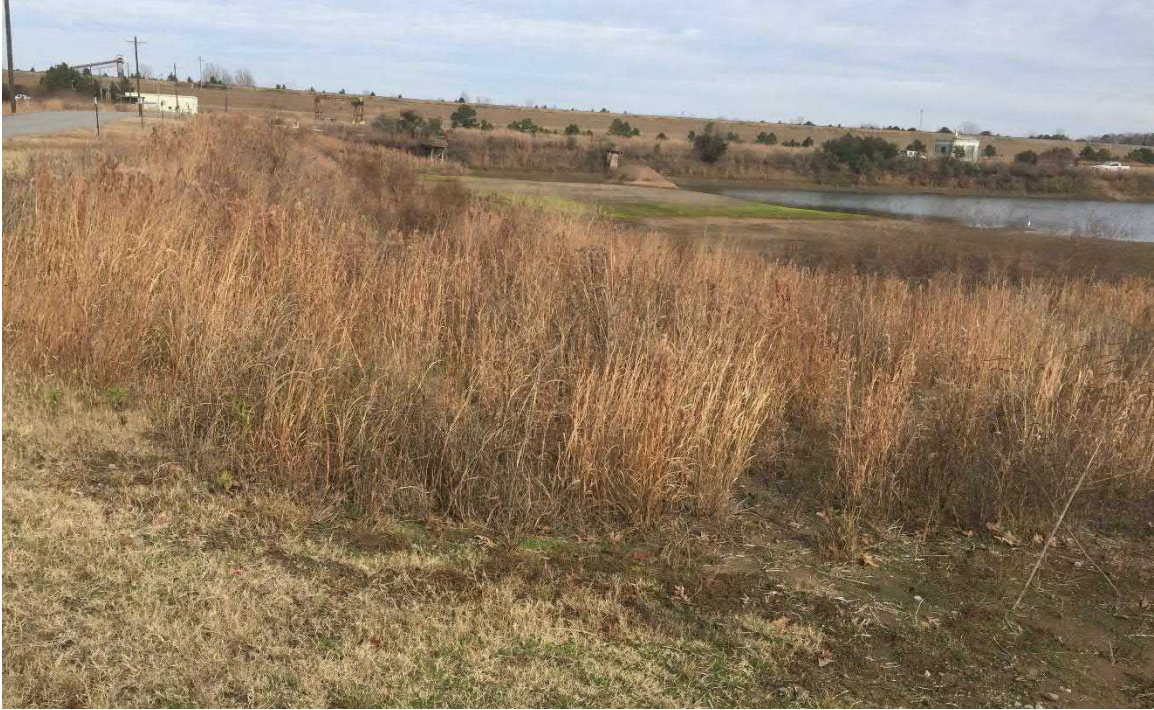
1. Looking north from southwest corner of Pond A. Stormwater is present/retained in the pond.

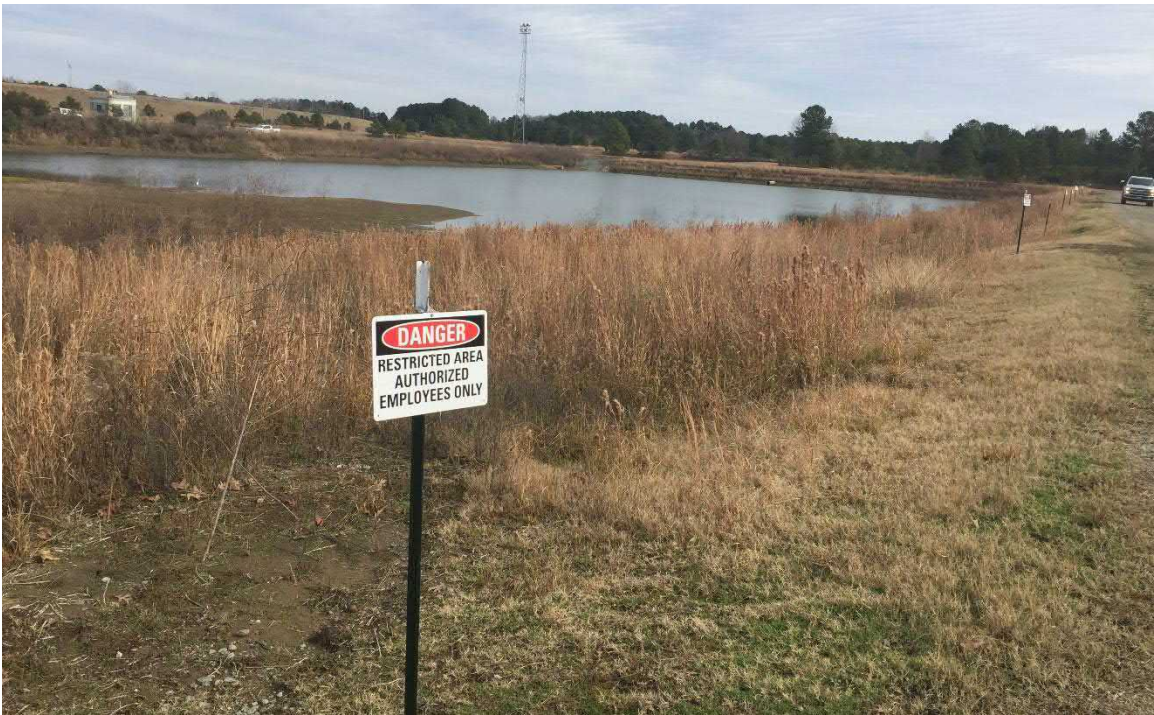
2. Looking northeast from southwest corner of Pond A. Stormwater is present/retained in the pond.

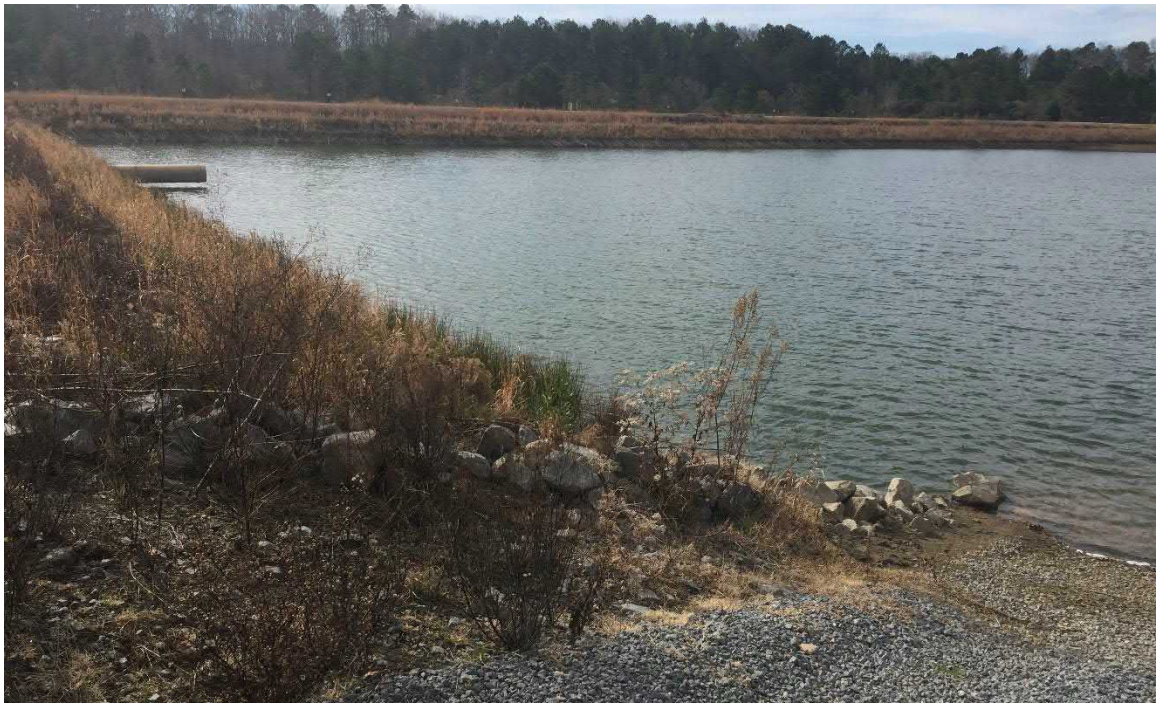
3. Looking southwest from northeast corner of Pond A. Stormwater is present/retained in the pond.

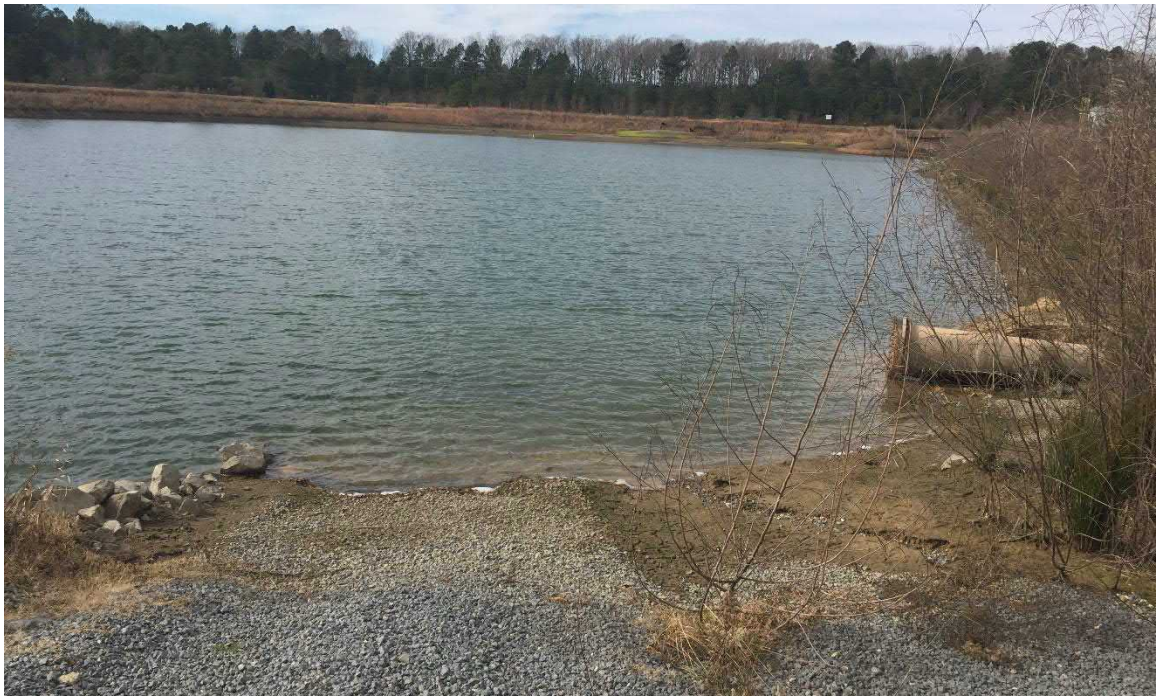
4. Looking west from northeast corner of Pond A. Stormwater is present/retained in the pond.
