# **2015 ANNUAL ENGINEERING INSPECTION REPORT**

## **ENERGY INDEPENDENCE PLANT CLASS 3N LANDFILL**

**PERMIT NO. 0200-S3N-R2  
AFIN: 32-00042**

**JANUARY 15, 2016**

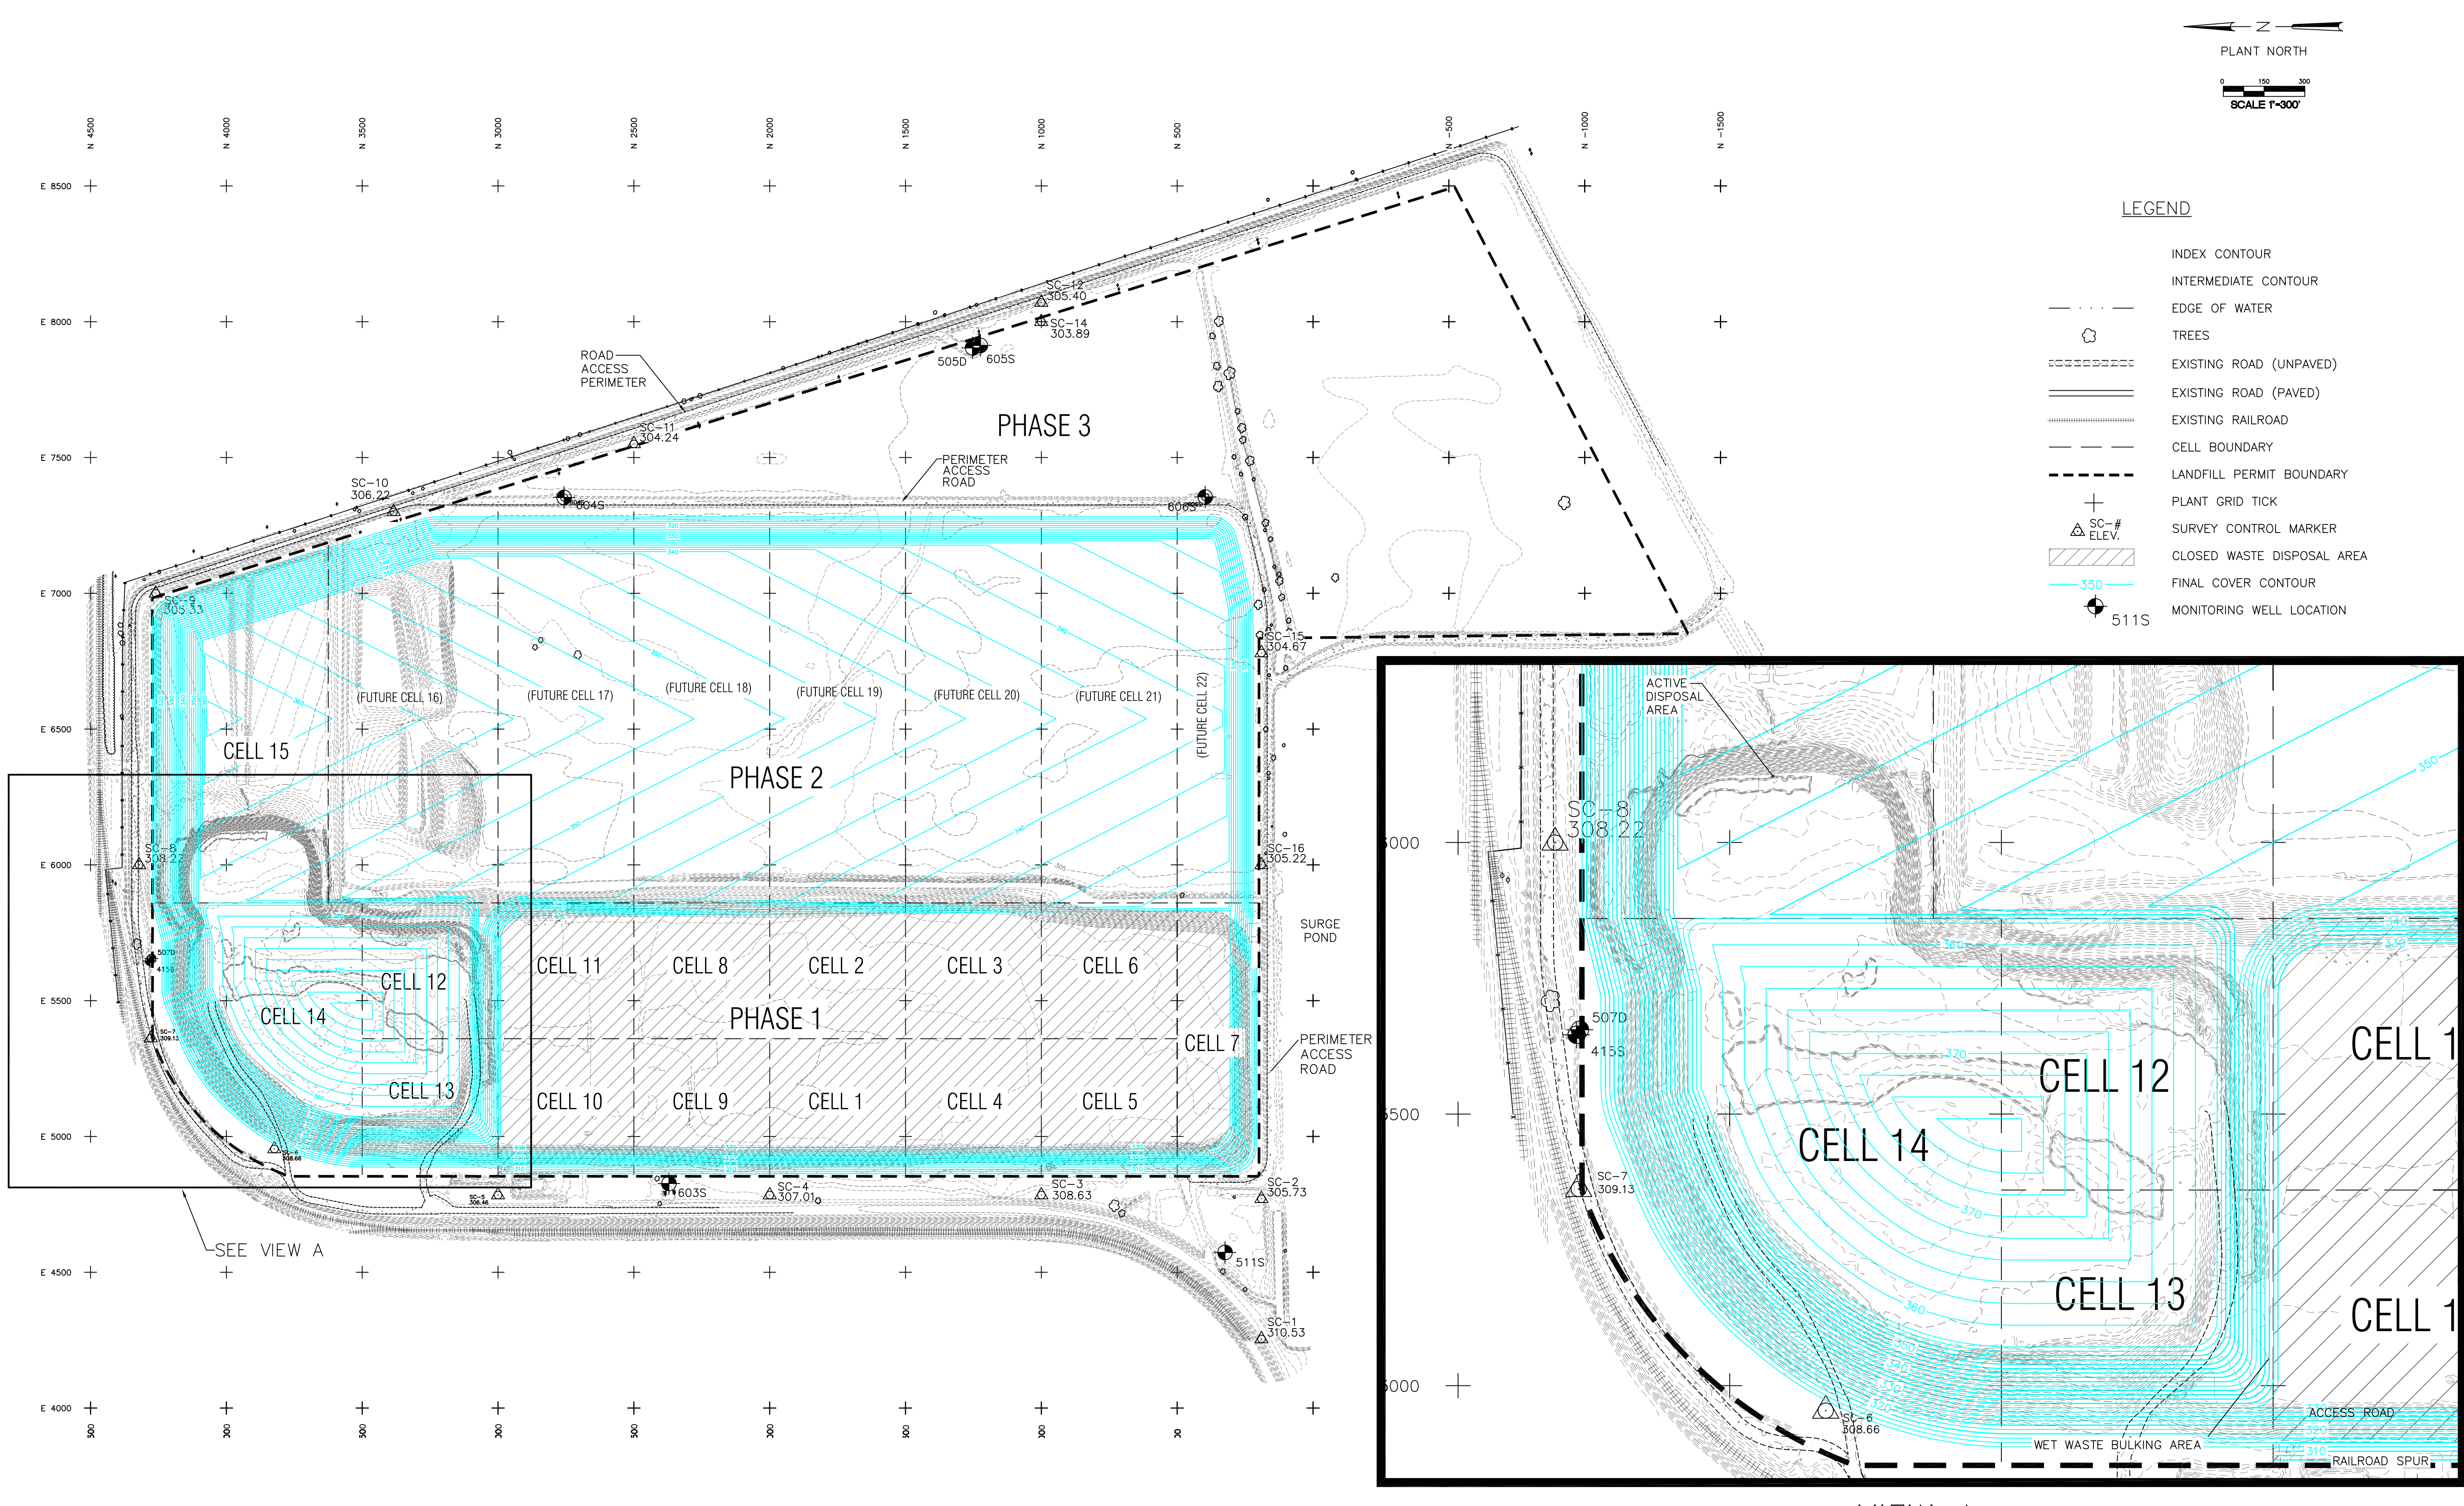
**FIGURE 3  
FINAL PERMIT CONTOURS**

Based upon the digital terrain model, the net volume of material filled in Waste Cells 12 through 15 during the reporting period was calculated to be approximately 48,700 cubic yards (cy). Final permitted contours are shown in Figure 3. Based upon a 5-year historical annual average disposal rate of approximately 124,800 cy of material, there are about 8.9 years of capacity left in Waste Cells 12 through 15. This time frame is affected by the market for ash material and may be shorter or longer depending on market conditions.
