**ENTERGY WHITE BLUFF PLANT
RECYCLE POND A AND RECYCLE POND B**

**DEMONSTRATION OF COMPLIANCE WITH
EPA CCR RULE SITING CRITERIA
§257.63, SEISMIC IMPACT ZONE**

**PREPARED IN COMPLIANCE WITH THE
EPA FINAL RULE FOR THE DISPOSAL OF
COAL COMBUSTION RESIDUALS
TITLE 40 CODE OF FEDERAL REGULATIONS PART 257**

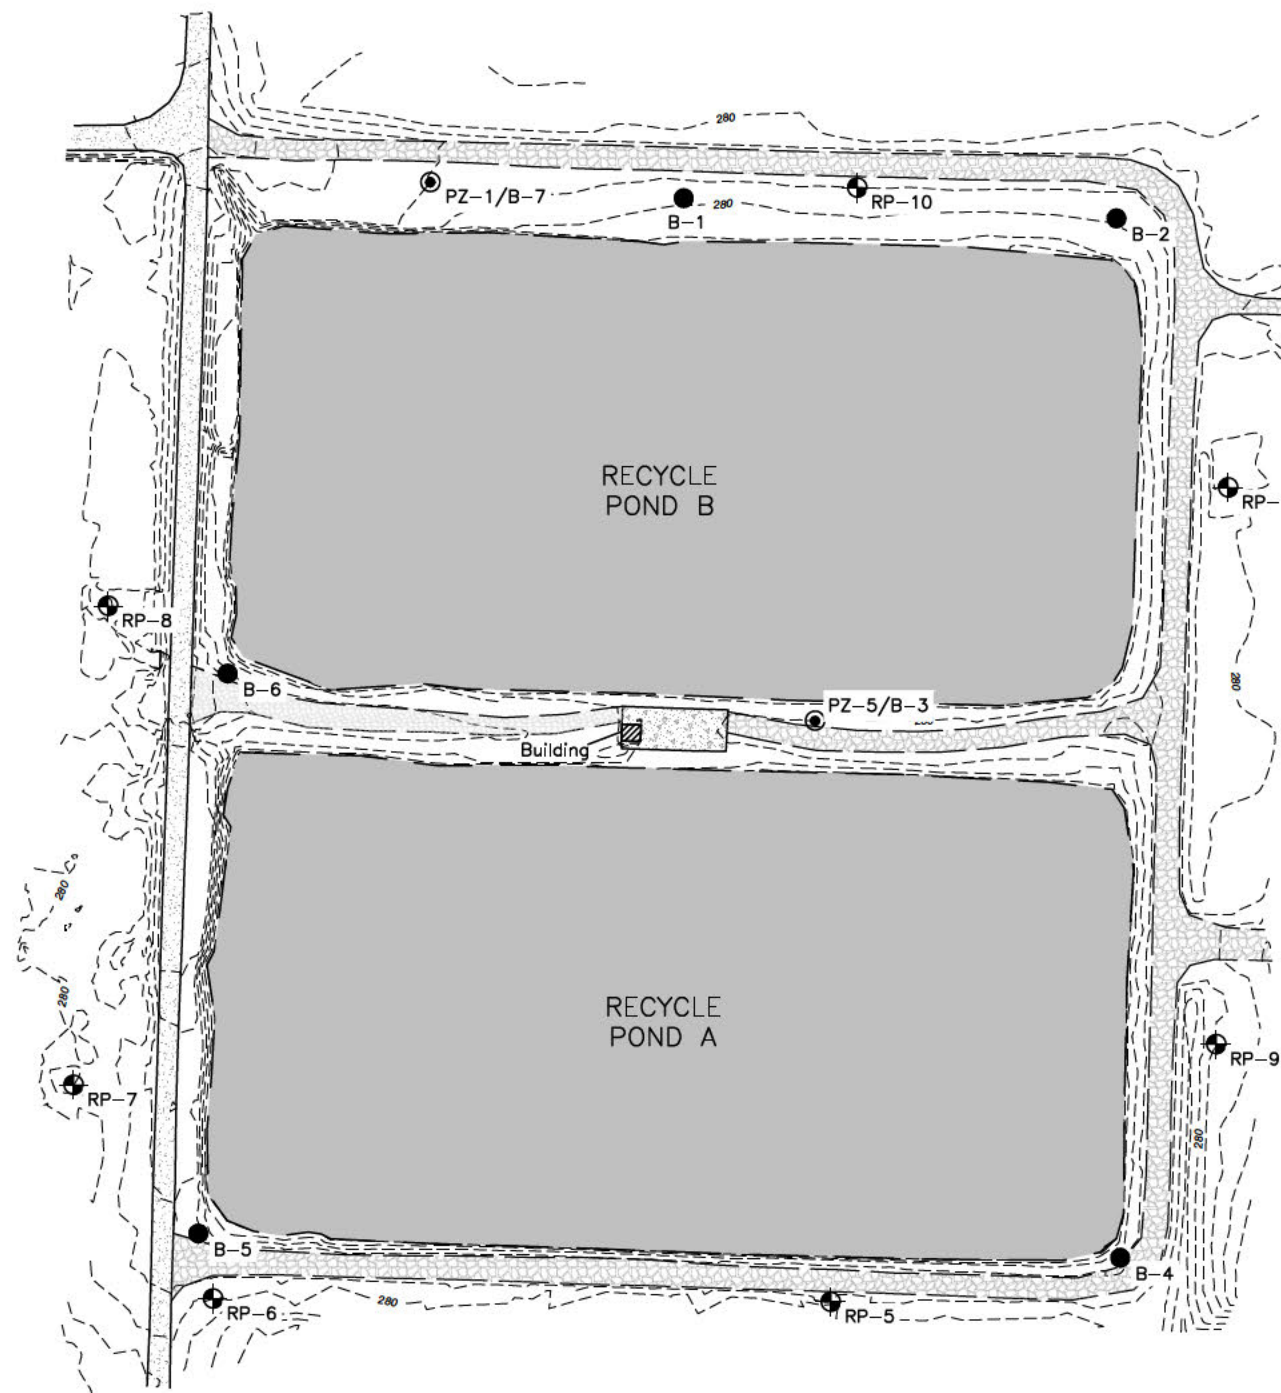
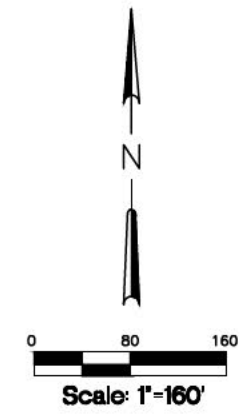
Figure 1. Site map, Entergy White Bluff recycle ponds.

Recycle Pond A and Recycle Pond B are shown on Figure 1 (all figures are located in Appendix A). Recycle Pond A has an approximate surface area of 7.0 acres and Recycle Pond B has an approximate surface area of 6.5 acres¹. The typical water level elevation in each pond is approximately 278 ft North American Vertical Datum of 1988 (NAVD88) based on a June 2018 field survey. Topography surrounding the immediate vicinity of the recycle ponds was graded during plant construction and is generally flat-lying, with existing ground surface elevations ranging from approximately 277 to 285 ft NAVD88, as shown on Figures 1 and 2. Natural topography in the vicinity of the ponds is gently to steeply sloping (Figure 2).

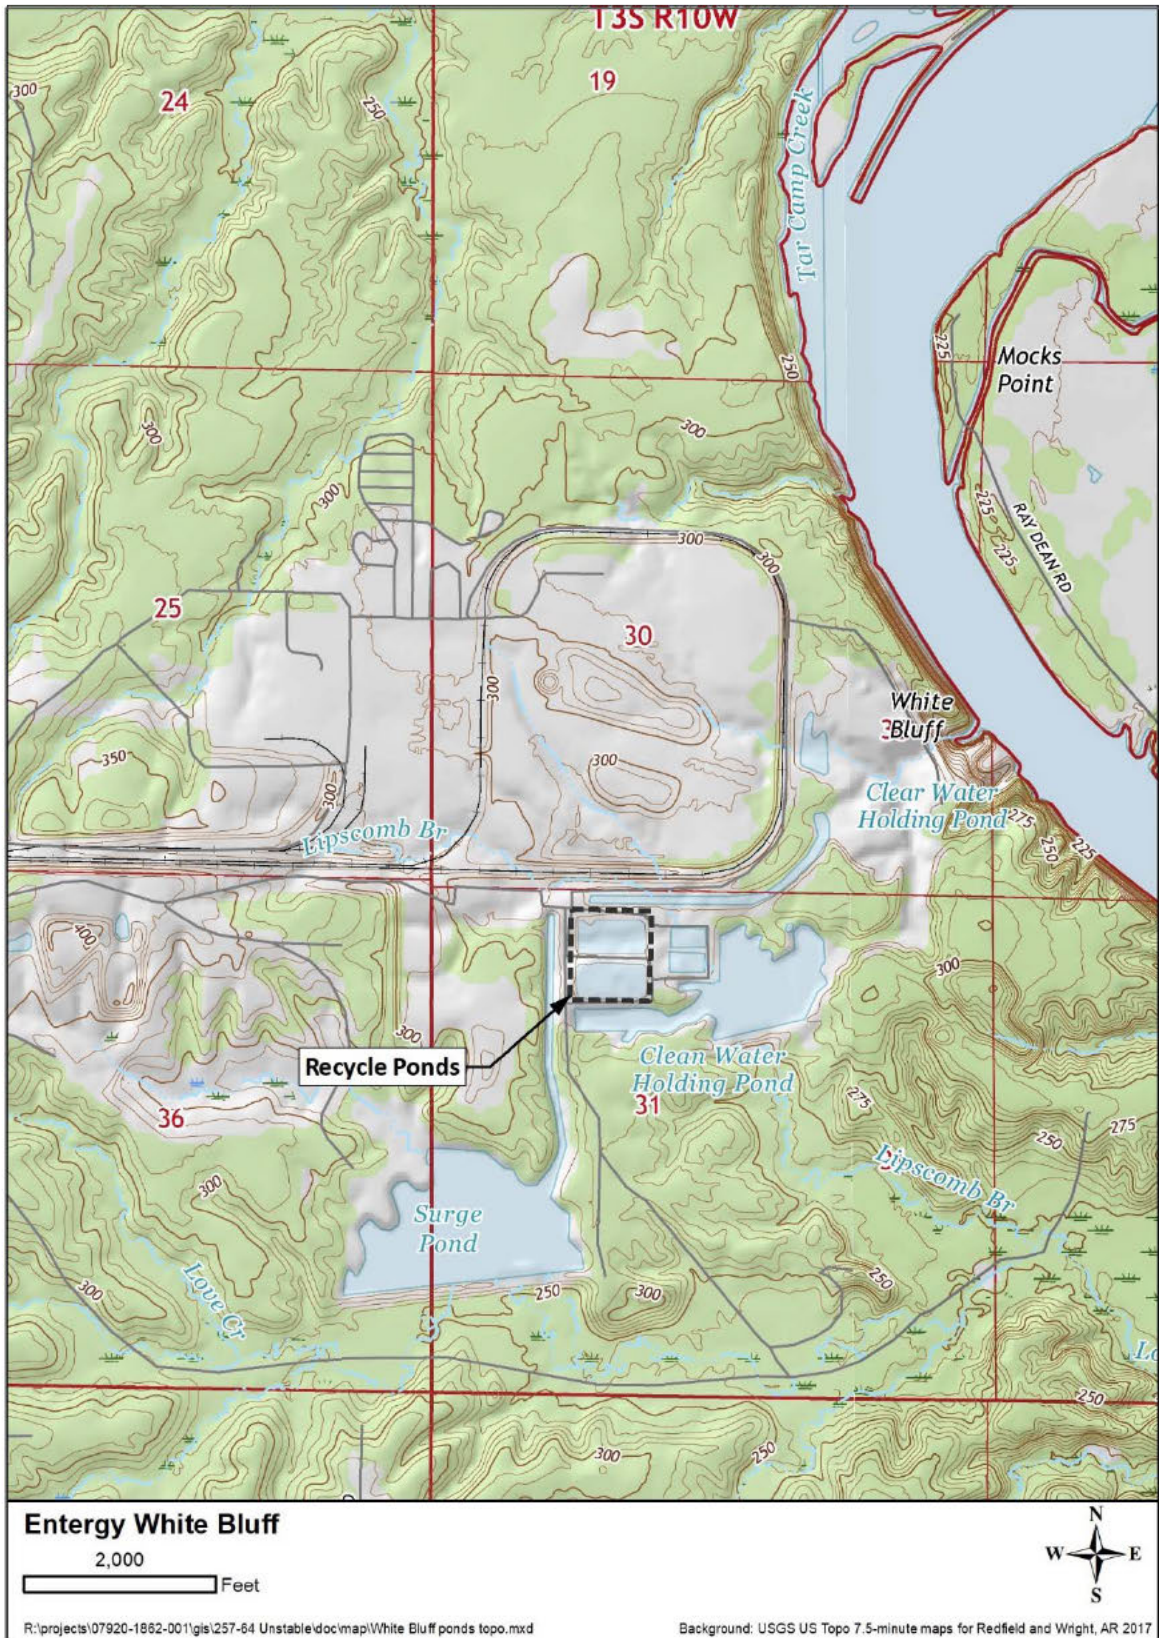
Figure 2. Topography of the recycle ponds and surrounding area based on USGS topographic quadrangles Redfield, AR, and Wright, AR (2017).
